# XRD ANALYSIS

**REPORT NO:** 0224-1

**NAME:** RFQ - Manufactured stone

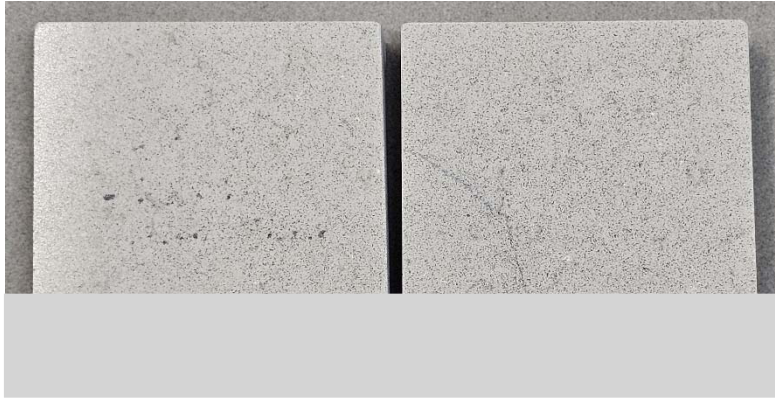
**Image 1:** Appearance of sample as received from client.

Photograph of sample tested presented overleaf.
